## Toyota Headquarters – Plano, Texas

### Toyota Headquarters Proves Excavation is Final Authority for Waterproofing Solutions

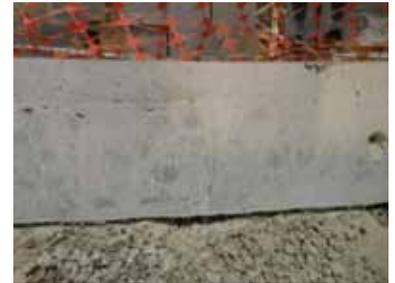
“Our guys thought adhesion was greatly enhanced and the membrane went down much faster,” Jahant said. “It definitely has an aggressive bond at the laps. There was an area where the concrete workers had a problem with the pour and had to remove a section of the floor slab. Typically you don’t see under the slab

once it’s installed. But we had to cut out an area to fix it. We could see the product was well-bonded to underside of the slab. That was impressive.” *(See top right photo)*
